Example Application of Rapid Visual Screening

Rapid Visual Screening of Buildings for Potential Seismic Hazards

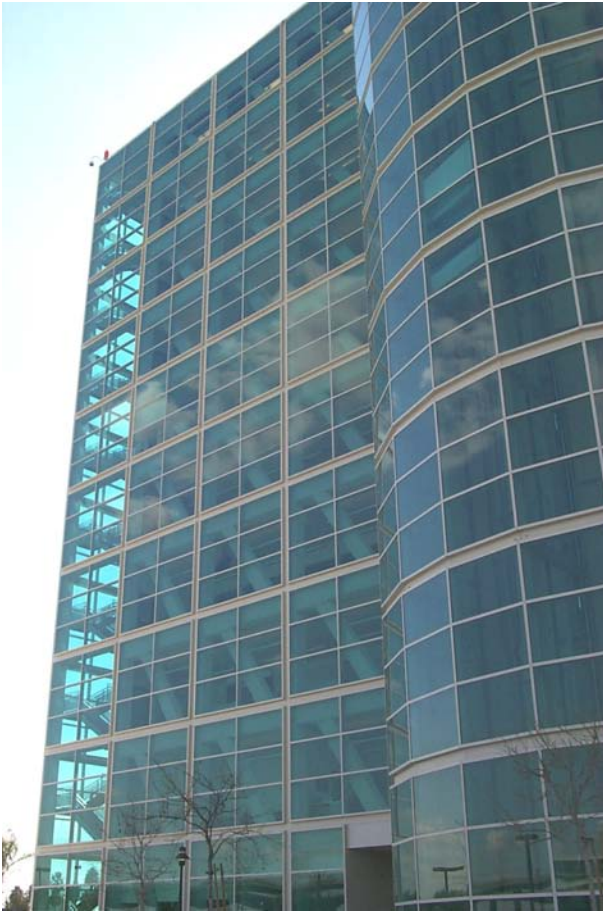
Figure 5-5 Exterior view of 3703 Roxbury Street.

Upon arriving at the site the screeners observed the building as a whole (Figure 5-5) and began the process of verifying the information in the building identification portion of the form (upper right corner), starting with the street address. The building's lateral-force-resisting system (S2, steel braced frame) was verified by looking at the building with binoculars (see Figure 5-6). The number of stories (10), use (office), and year built (1986) were also confirmed by inspection. The base dimensions of the building were estimated by pacing off the distance along each face, assuming 3 feet per stride, resulting in the determination that it was 75 ft x 100 ft in plan.

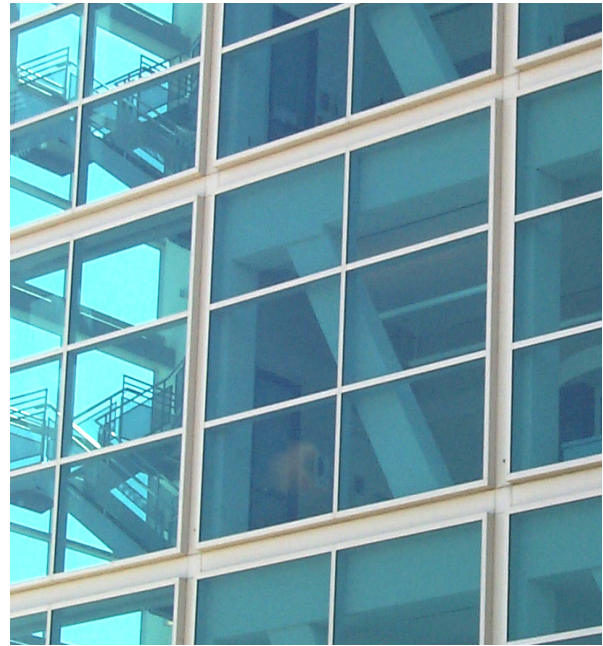
Figure 5-6 Close-up view of 3703 Roxbury Street exterior showing perimeter braced steel framing.

The next step in the process was to circle the appropriate Basic Structural Hazard Score and the appropriate Score Modifiers. Having verified the lateral-force-resisting system as S2, this code was circled along with the Basic Structural Score beneath it (see Figure 5-8). Because the building is high rise (8 stories or more) this modifier was circled. Noting that the soil is type D, as already determined during the pre-field data acquisition phase and indicated in the Soil Type portion of the form, the modifier for Soil Type D was circled. By adding the column of circled numbers, a Final Score of 3.2 was determined. Because this score was greater than the cut-off score of 2.0, the building did not require a detailed evaluation by an experienced seismic design professional. Lastly, an instant camera photo of the building was attached to the form.

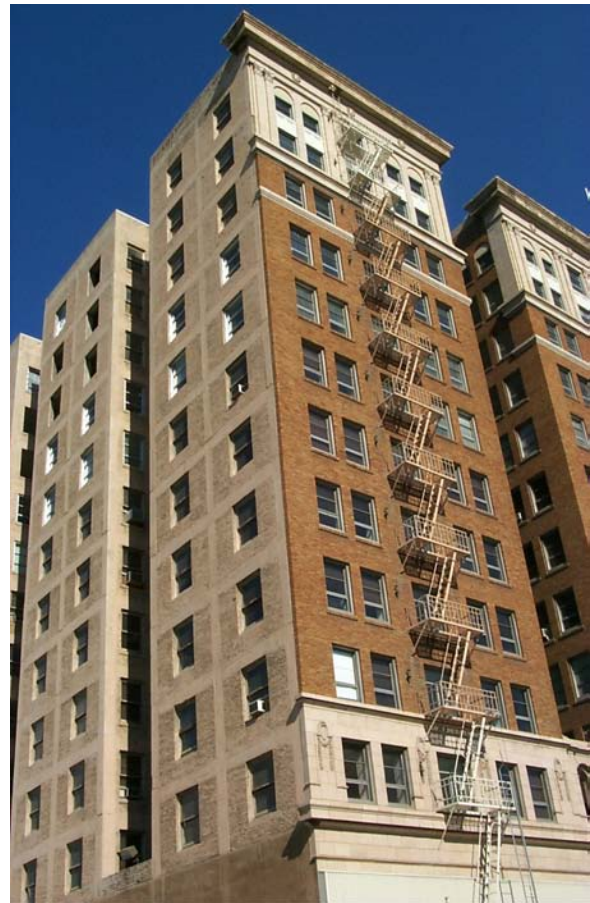
Figure 5-9 Exterior view of 3711 Roxbury.

Upon arrival at the site, the screeners observed the building as a whole (Figure 5-9). Unlike Example 1, there was little information in the building identification portion of the form (only street address, zip code, and parcel number were provided). The screeners determined the number of stories to be 12 and the building use to be commercial and office. They paced off the building plan dimensions to estimate the plan size to be 58 feet x 50 feet. Based on this information, the total square footage was estimated to be 34,800 square feet (12 x 50 x 58), and the number of stories, use, and square footage were written on the form. Based on a review of information in Appendix D of this *Handbook*, the year of construction was estimated to be 1944 and this date was written on the form.

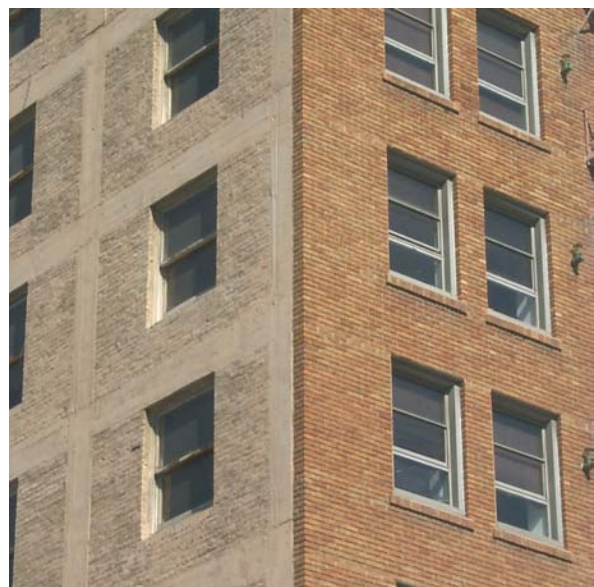
Figure 5-10 Close-up view of 3711 Roxbury Street building exterior showing infill frame construction.

Noting that the estimated construction date was 1944 and that it was a 12-story building, a review of the material in Table D-6 (Appendix D), indicated that the likely options for building type were S1, S2, S5, C1, C2, or C3. On more careful examination of the building exterior with the use of binoculars (see Figure 5-10), it was determined the building was type C3, and this alpha-numeric code, and accompanying Basic Structural Score, were circled on the Data Collection Form.

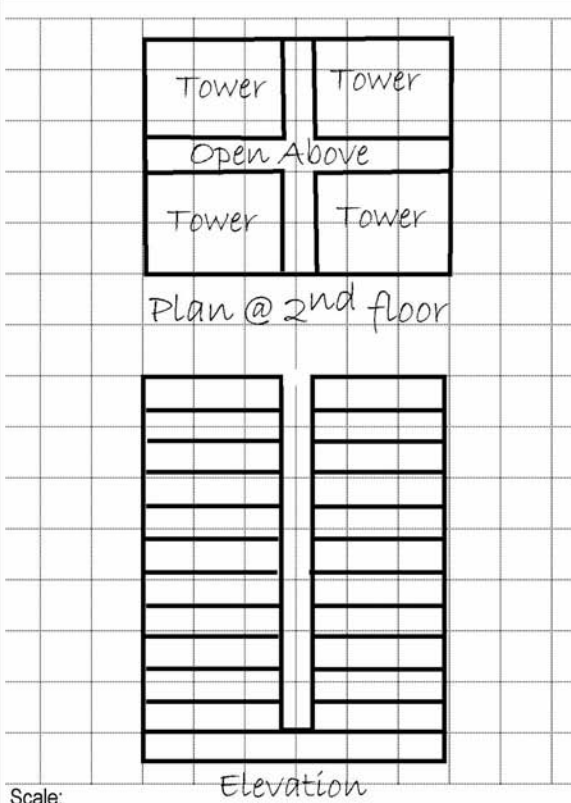
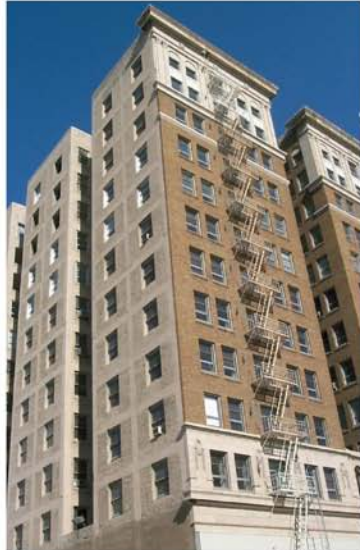
Figure 5-11 Completed Data Collection Form for Example 2, 3711 Roxbury Street.

By adding the column of circled numbers, a Final Score of 0.5 was determined. Because this score was less than the cut-off score of 2.0, the building required a detailed evaluation by an experienced seismic design professional. Lastly,

an instant camera photo of the building was attached to the Data Collection Form (a completed version of the form is provided in Figure 5-11).

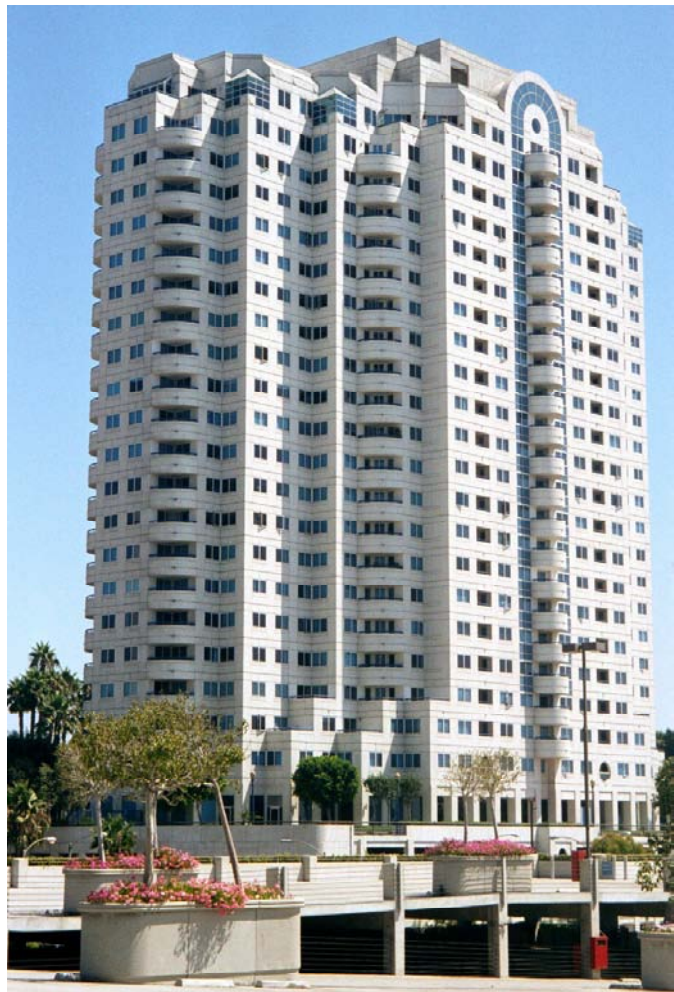
Figure 5-12 Exterior view of 5020 Ebony Drive.

Example 3 was a high-rise residential building (Figure 5-12) in a new part of the city in which new development had begun within the last few years. The building was not included in the electronic Building RVS Database, and consequently there was not a partially prepared Data Collection Form for this building. Based on visual inspection, the screeners determined that the building had 22 stories, including a tall-story penthouse, estimated that it was designed in 1996, and concluded that its use was both commercial (in the first story) and residential in the upper stories. The screeners paced off the building plan dimensions to estimate the plan size to be approximately 270 feet x 180 feet. Based on this information and considering the symmetric but non-rectangular floor plan, the total square footage was estimated to be 712,800 square feet. These data were written on the form, along with the names of the screeners and the date of the screening. The screeners also drew a sketch of a portion of the plan view of the building in the space on the form allocated for a “Sketch”.

The window spacing in the upper stories and the column spacing at the first floor level indicated the building was either a steel moment-frame building, or a concrete moment-frame building. The screeners attempted to view the interior but were not provided with permission to do so. They elected to indicate that the building was either an S1 or C1 type on the Data Collection Form and

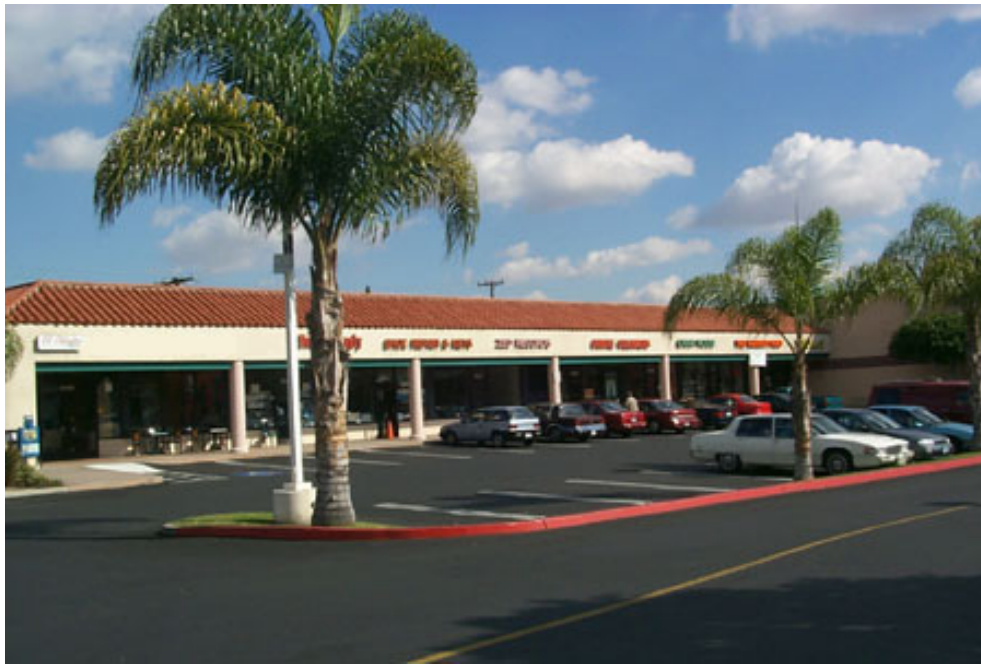
Figure 5-14 Exterior view of 1450 Addison Avenue.

The building at 1450 Addison Avenue (see Figure 5-14) was a 1-story commercial building designed in 1990, per the information provided in the building identification portion of the Data Collection Form. By inspection the screeners confirmed the address, number of stories, use (commercial), and year built (Figure 5-15). The screeners paced off the building plan dimensions to estimate the plan size (estimated to be 10,125 square feet), confirming the square footage shown on the identification portion of the form. The L-shaped building was drawn on the form, along with the dimensions of the various legs.

The building type (W2) was circled on the form along with its Basic Structural Score. Because the building was L-shaped in plan the modifier for plan irregularity was circled. Because soil type C had been circled in the Soil Type box (based on the information in the Building RVS Database) the modifier for soil type C was circled.
